EVALUATION STUDY OF  
RECENTLY COMPLETED  
SMALL NAVIGATION PROJECT FOR  
ANDREWS RIVER, MASSACHUSETTS

DEPARTMENT OF THE ARMY  
NEW ENGLAND DIVISION, CORPS OF ENGINEERS  
WALTHAM, MASSACHUSETTS 02154

SEPTEMBER 1971

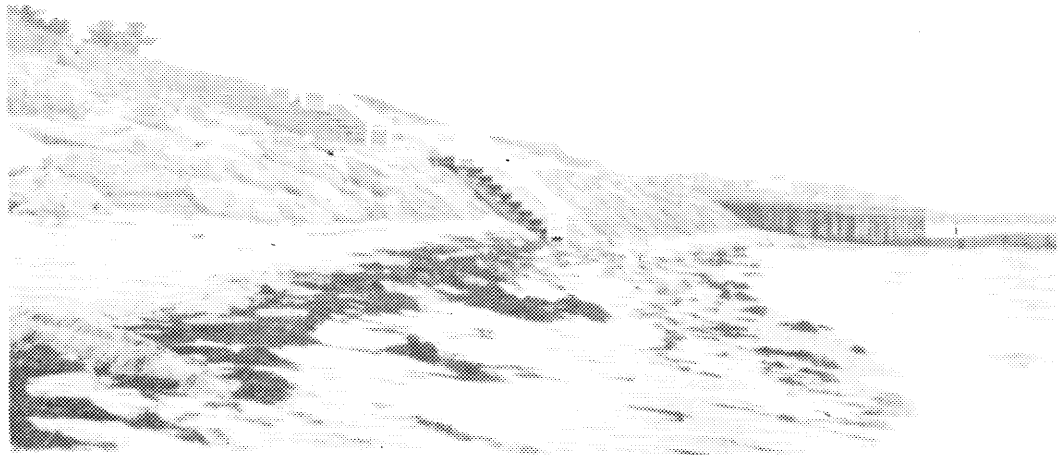
5. The Problem. The problem appears to involve several factors. These include erosion of a sector of shorefront immediately west of the entrance to Andrews River, shoaling of the entrance channel, and choppy wave action experienced at the channel entrance due to short period waves during onshore sea breezes. These waves are modified by some reflection from the east jetty and a nearby revetment structure. The erosion includes about 200 feet of the backshore area immediately west of the entrance channel. A property owner located within this sector has experienced a serious problem along a portion of his shorefront property resulting in lowering of the beach and moderate damage to the aforementioned protective revetment. These damages have required structural repairs and additional erosion control work by the property owner. Since his additional improvements were completed, (stone revetment sealed with concrete that fronts an embankment and a sector of dunes), a substantial portion of his structure has been overtopped and flanked, resulting in substantial undermining and deterioration. Natural unprotected dunes forming the backshore and extending east of the structure to the channel are experiencing erosion during frequent severe storms. See PHOTOS 1 through 4 demonstrating this problem.

PHOTO 1., AUGUST 1969. Looking east at revetment along front of private property west and adjacent to Andrews River at mid-tide.

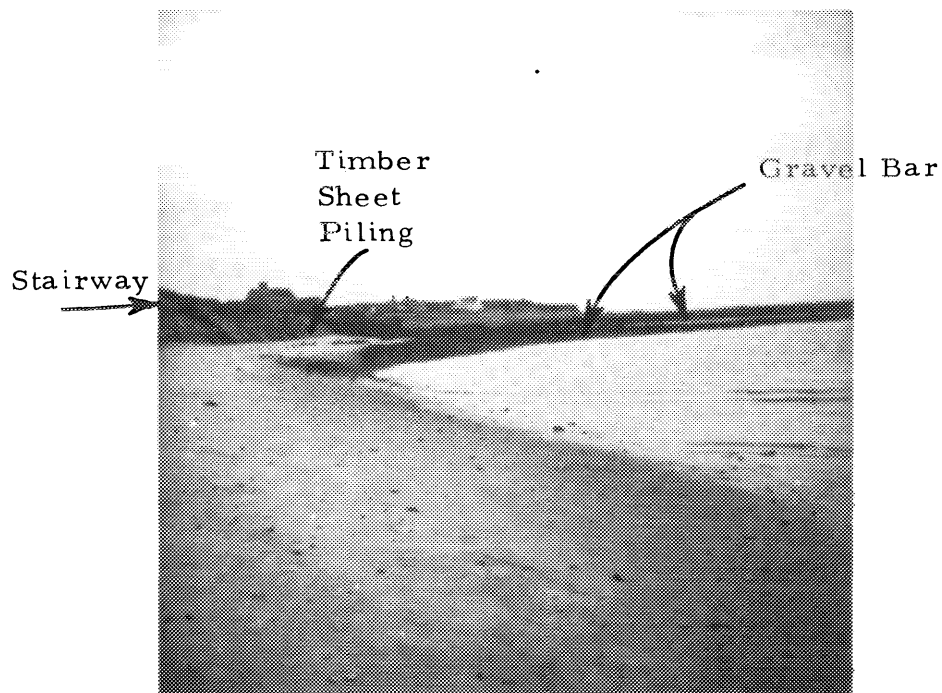
6. The beach backshore and foreshore along the damaged sector is now very rocky in contrast to the beach sand shorefront that existed prior to the construction of the navigation project. During dredging of Wychmere Harbor by the Commonwealth of Massachusetts, about ten years ago, a substantial amount of sand was pumped into the beach between Wychmere Harbor and the Andrews River. A stony, ridge-shaped bar extending seaward for some distance adjacent to and paralleling the western edge of the navigation channel has formed. Apparently, this also forms a portion of the material that is shoaling along the western portion of the entrance channel within the limits of and paralleling the east jetty structure. The rocky condition of the immediate backshore and nearshore area, with a scoured narrow sector of beach paralleling and adjacent to the stony bar, indicates the severity of erosion. The scouring action appears to be extending in a westerly

PHOTO 2., DECEMBER 1970. Looking along this private beach area, about one year later. Note rock deposits, now exposed top of timber sheet piling, and inner end of gravel bar, demonstrating erosion fronting private property.

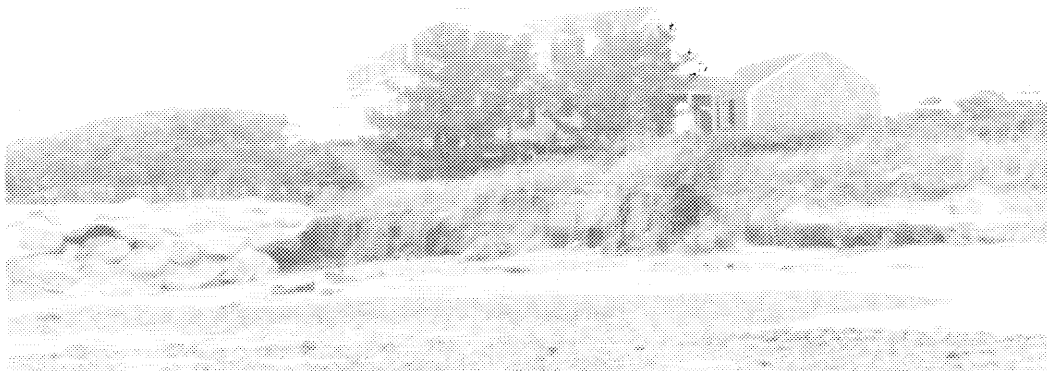
PHOTO 3., AUGUST 1969. Looking at reveted portion of privately-owned shorefront on west bank of river. Note continuing erosion of backshore adjacent to revetment.

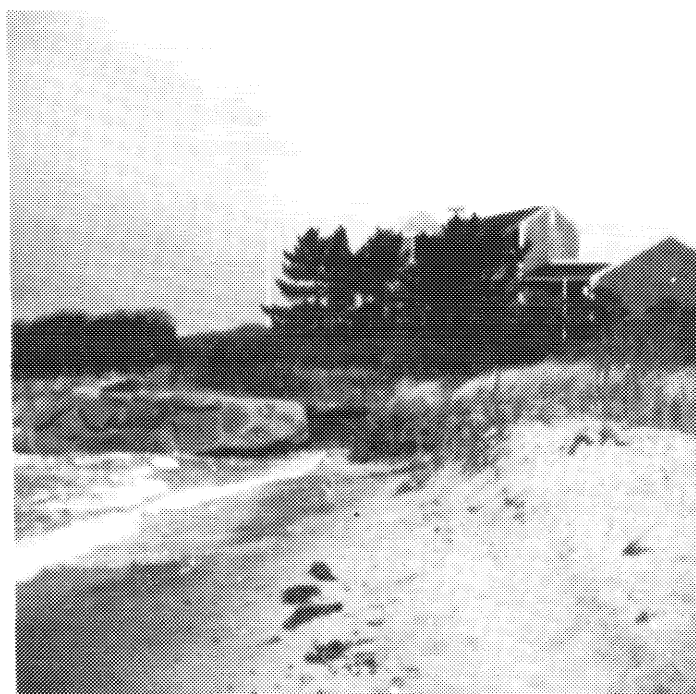
PHOTO 4., DECEMBER 1970. Private property owner extends revetment, erosion continues. Recommended improvement would tie into this structure and protect eroding dunes.

22. Recommendations. It is recommended that the improvement, as shown on PLATE 9 be constructed. This improvement consists of a 700-foot long jetty structure extending along the west side of the channel paralleling the east jetty and tying into alongshore revetment that terminates at the privately constructed revetment about 100 feet west of the channel.

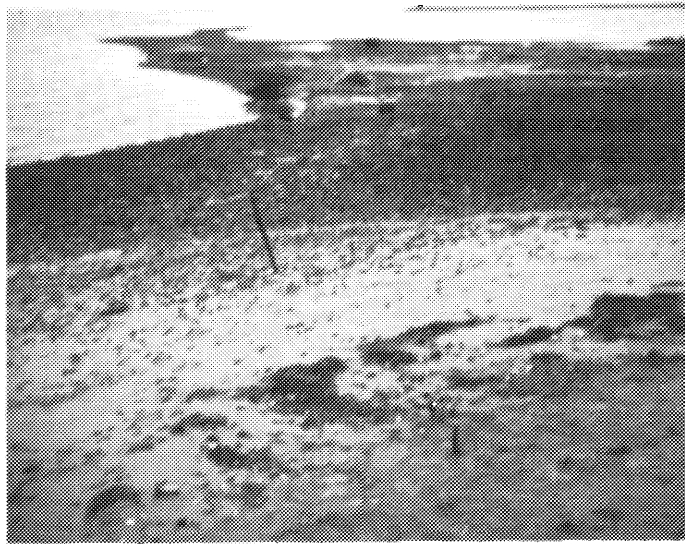
9. The characteristics of the shoaling material are not positively known, because a costly foundation analysis including coring data was not made. Based on visual observations made, during periods of low tides, a large proportion of the material is likely gravelly, similar to the stony nature of material forming the bar that extends seaward paralleling the western side of the entrance channel. This type of material apparently forms much of the geological structure of the near-shore area where storm-driven waves have removed most of the fines. A substantial amount of fines probably moves into the channel, however, through the predominant easterly drift of material either from the backshore of the Wychmere Harbor-Andrews River sector, or by material moving around the outer arm of the Wychmere Harbor jetty and beyond its effective area of diffraction.

PHOTO 5., DECEMBER 1970. Looking soundward at low tide, along the bar that has formed along west side of the Andrews River.

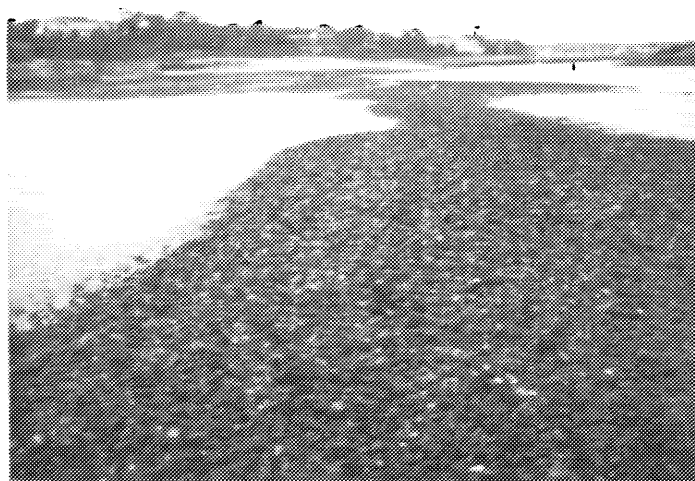
PHOTO 6., DECEMBER 1970. Looking inland at about low tide along the stony bar.

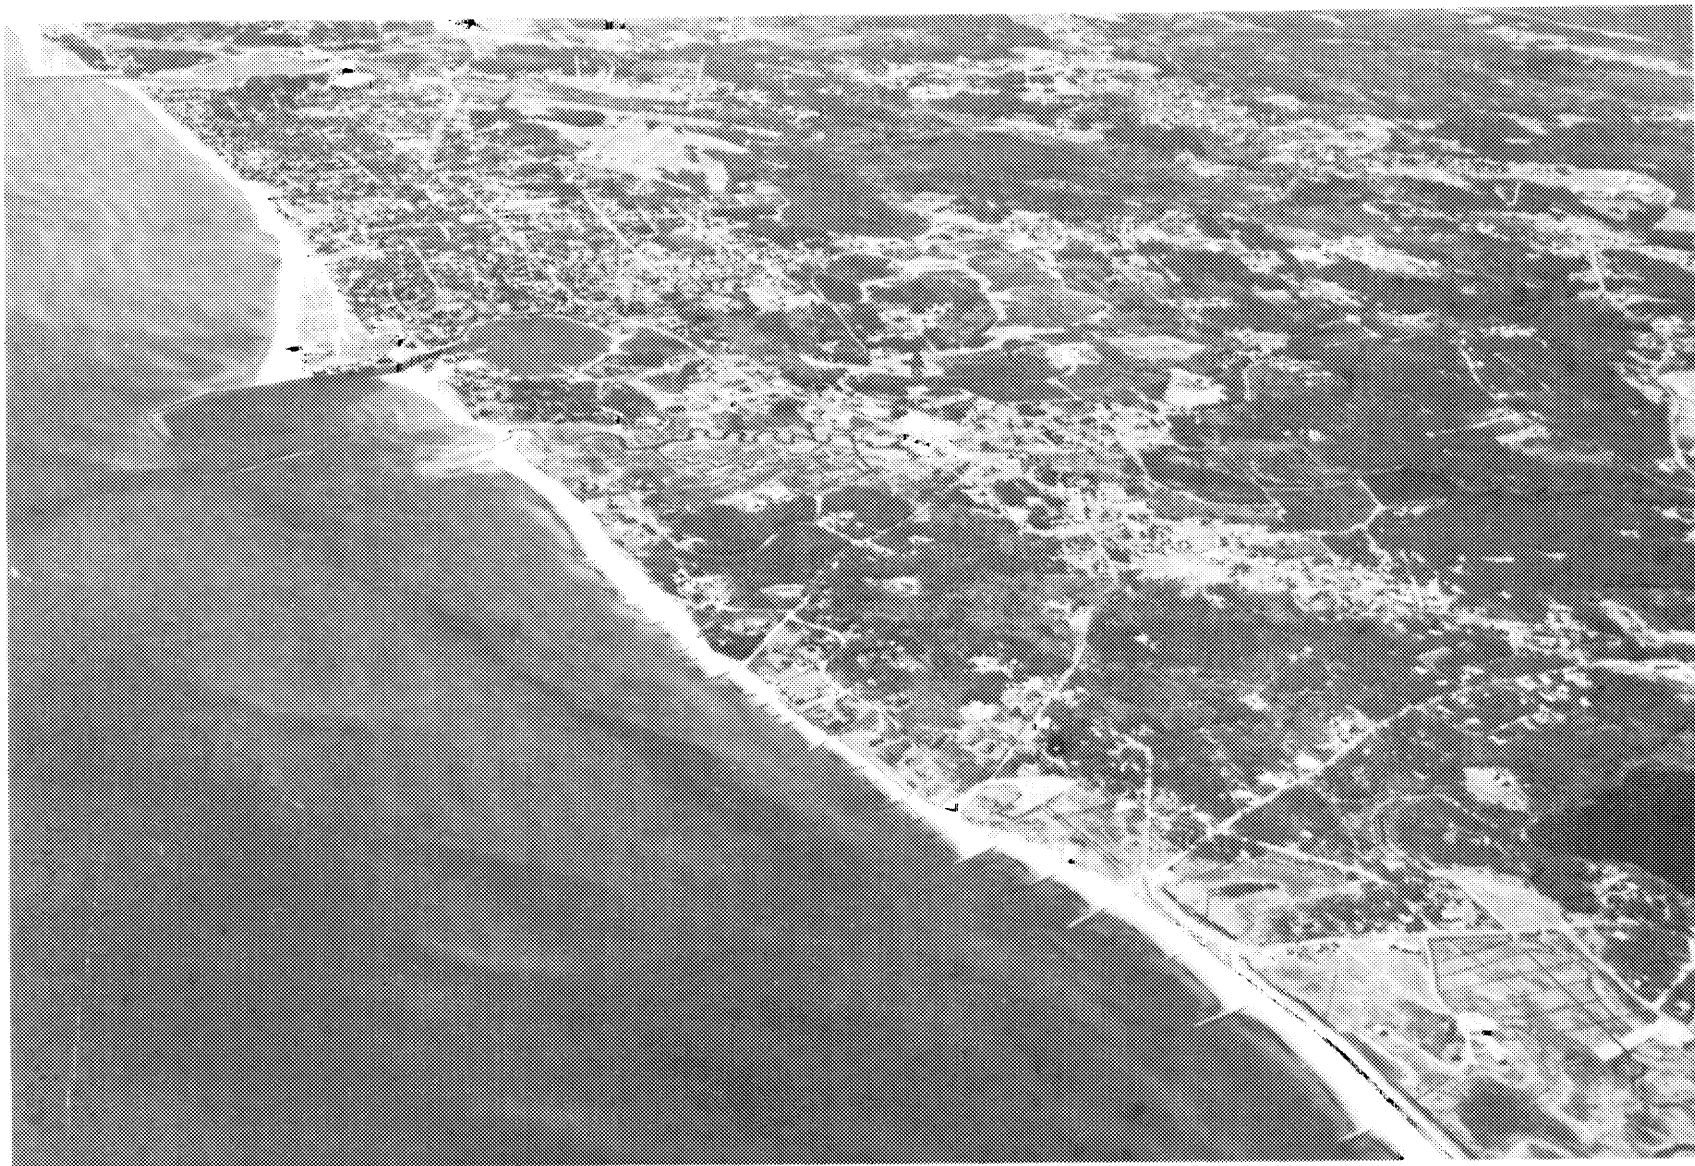
10. Discussion of Processes and Protective Measure. There are several factors that relate to the shoaling problem. Of major importance, is the predominant easterly direction of littoral drift experienced during frequent storms (southwesterly through south-easterly storms). Substantial quantities of materials are, therefore, transported littorally toward the channel. Millions of cubic yards of sand are available along the flat shallow nearshore and sandy backshore area to the west of Andrews River and east of the Wychmere Harbor jetty. The project is located outside the limit of substantial diffraction capability of the Wychmere Harbor jetty. The predominant easterly drift of material is physically demonstrated by the build up of beach sand on the west side of groins and the Wychmere Harbor jetty structure as portrayed by PHOTO 7. The channel is actually a 6-foot by 75-foot wide cut through the beach proper, with the east jetty extending seaward to a shallow depth (2 feet below mean low water) and paralleling the eastern edge of the channel. Prior to construction of the channel, the natural discharge of the river extended over a broad width to the east and west of the natural channel with the deepest natural channel depth through the backshore then ranging only up to 1 foot below mean low water. The flood and ebb tide flows were then quite rapid during low tides. As a result, the tidal flow velocity swept substantial amounts of fine material along in the tidal current forming a sandy and gravelly delta at the mouth (see PHOTO 7).

PHOTO 7., APRIL 1965. Looking west toward Wychmere Harbor Jetty and Andrews River at time of near high tide. Note predominant easterly drift as demonstrated generally by sand buildup on west side of jetty and groins and sandy delta at mouth of Andrews River.

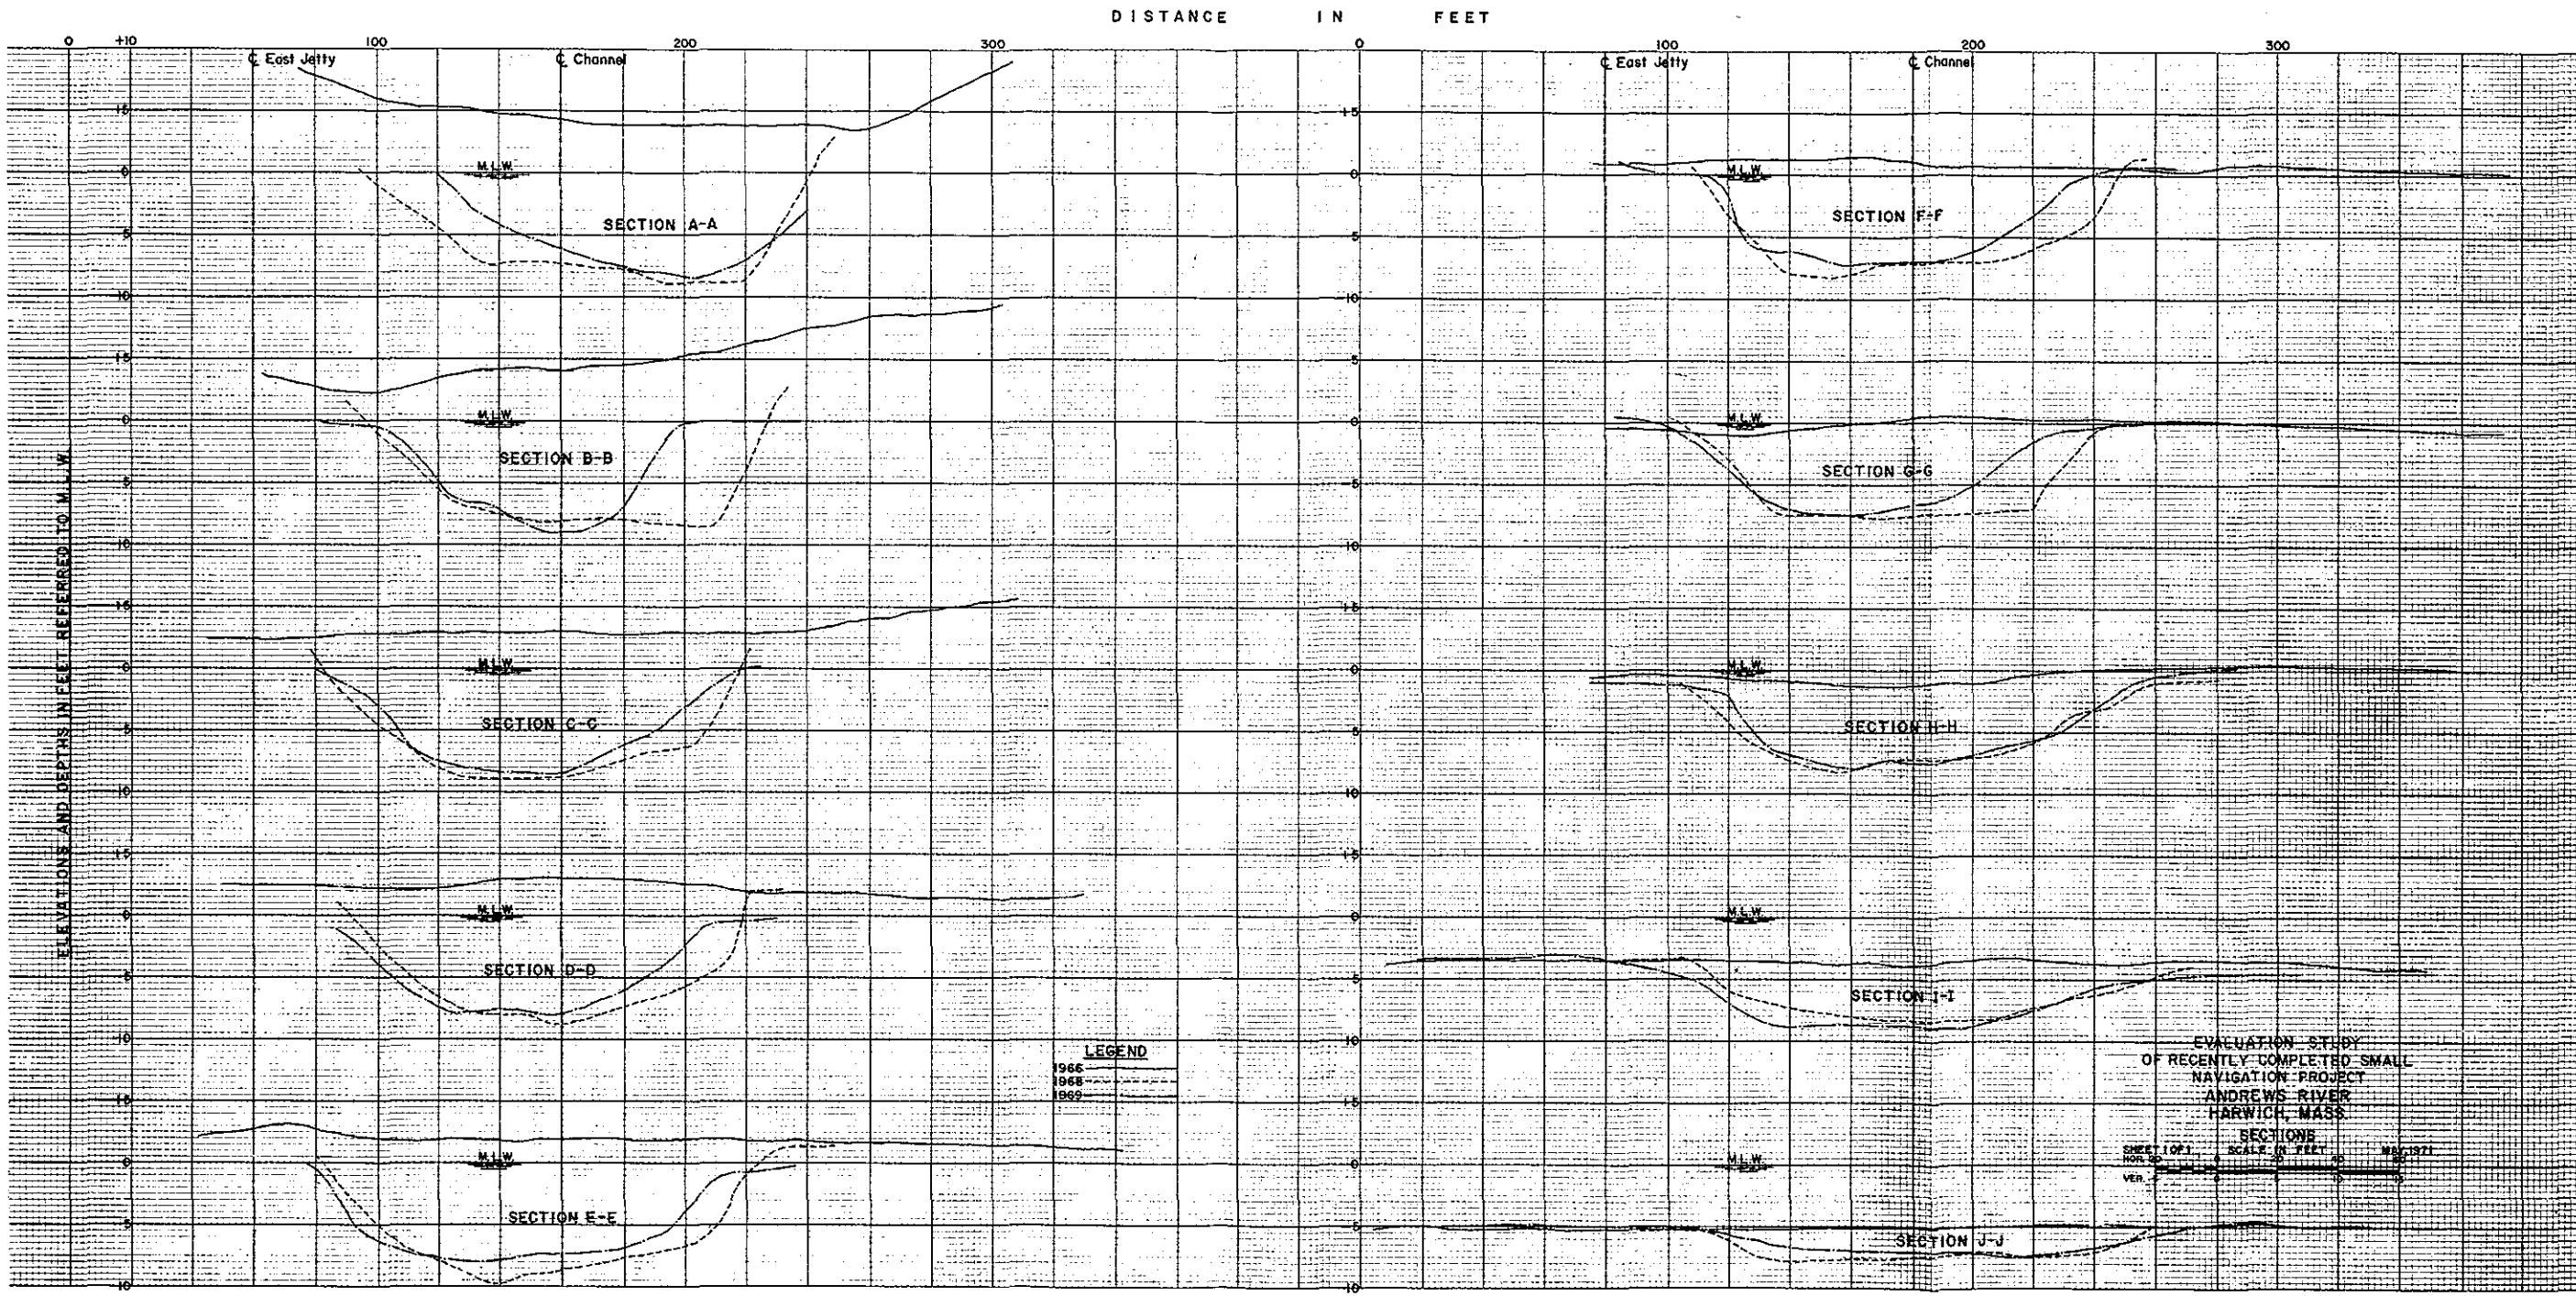
EVALUATION STUDY  
OF RECENTLY COMPLETED SMALL  
NAVIGATION PROJECT  
ANDREWS RIVER  
HARWICH, MASS.  
SECTIONS  
SHEET 1001 SCALE IN FEET MAY 1971  
VER.

8. Shoaling - Comparative Profiles. Based on the comparative profiles as shown on PLATES 2 through 4 of the surveyed condition of the channel before construction (1966), after construction (1968) and one year later (1969), a computation of shoaling quantities has been made. The major proportion of the shoaling material is located within the channel limits of the east jetty structure and the inner channel immediately within the mouth of the river (see PLATE 5 for cross sections). During a period of one year, since construction of the project, the amount of shoaling material within this area amounted to 5,800 cubic yards. There is little or no shoaling within the outer channel limits. No comparative surveys were taken in the inner harbor area but it is estimated that at least an additional 3,000 cubic yards attributed to movement from the outer shorefront has moved into the inner harbor. Thus a total of about 8,800 cubic yards of shoaling has occurred within one year since construction of the project or more than twice the estimated maintenance requirement as determined in the detailed study.

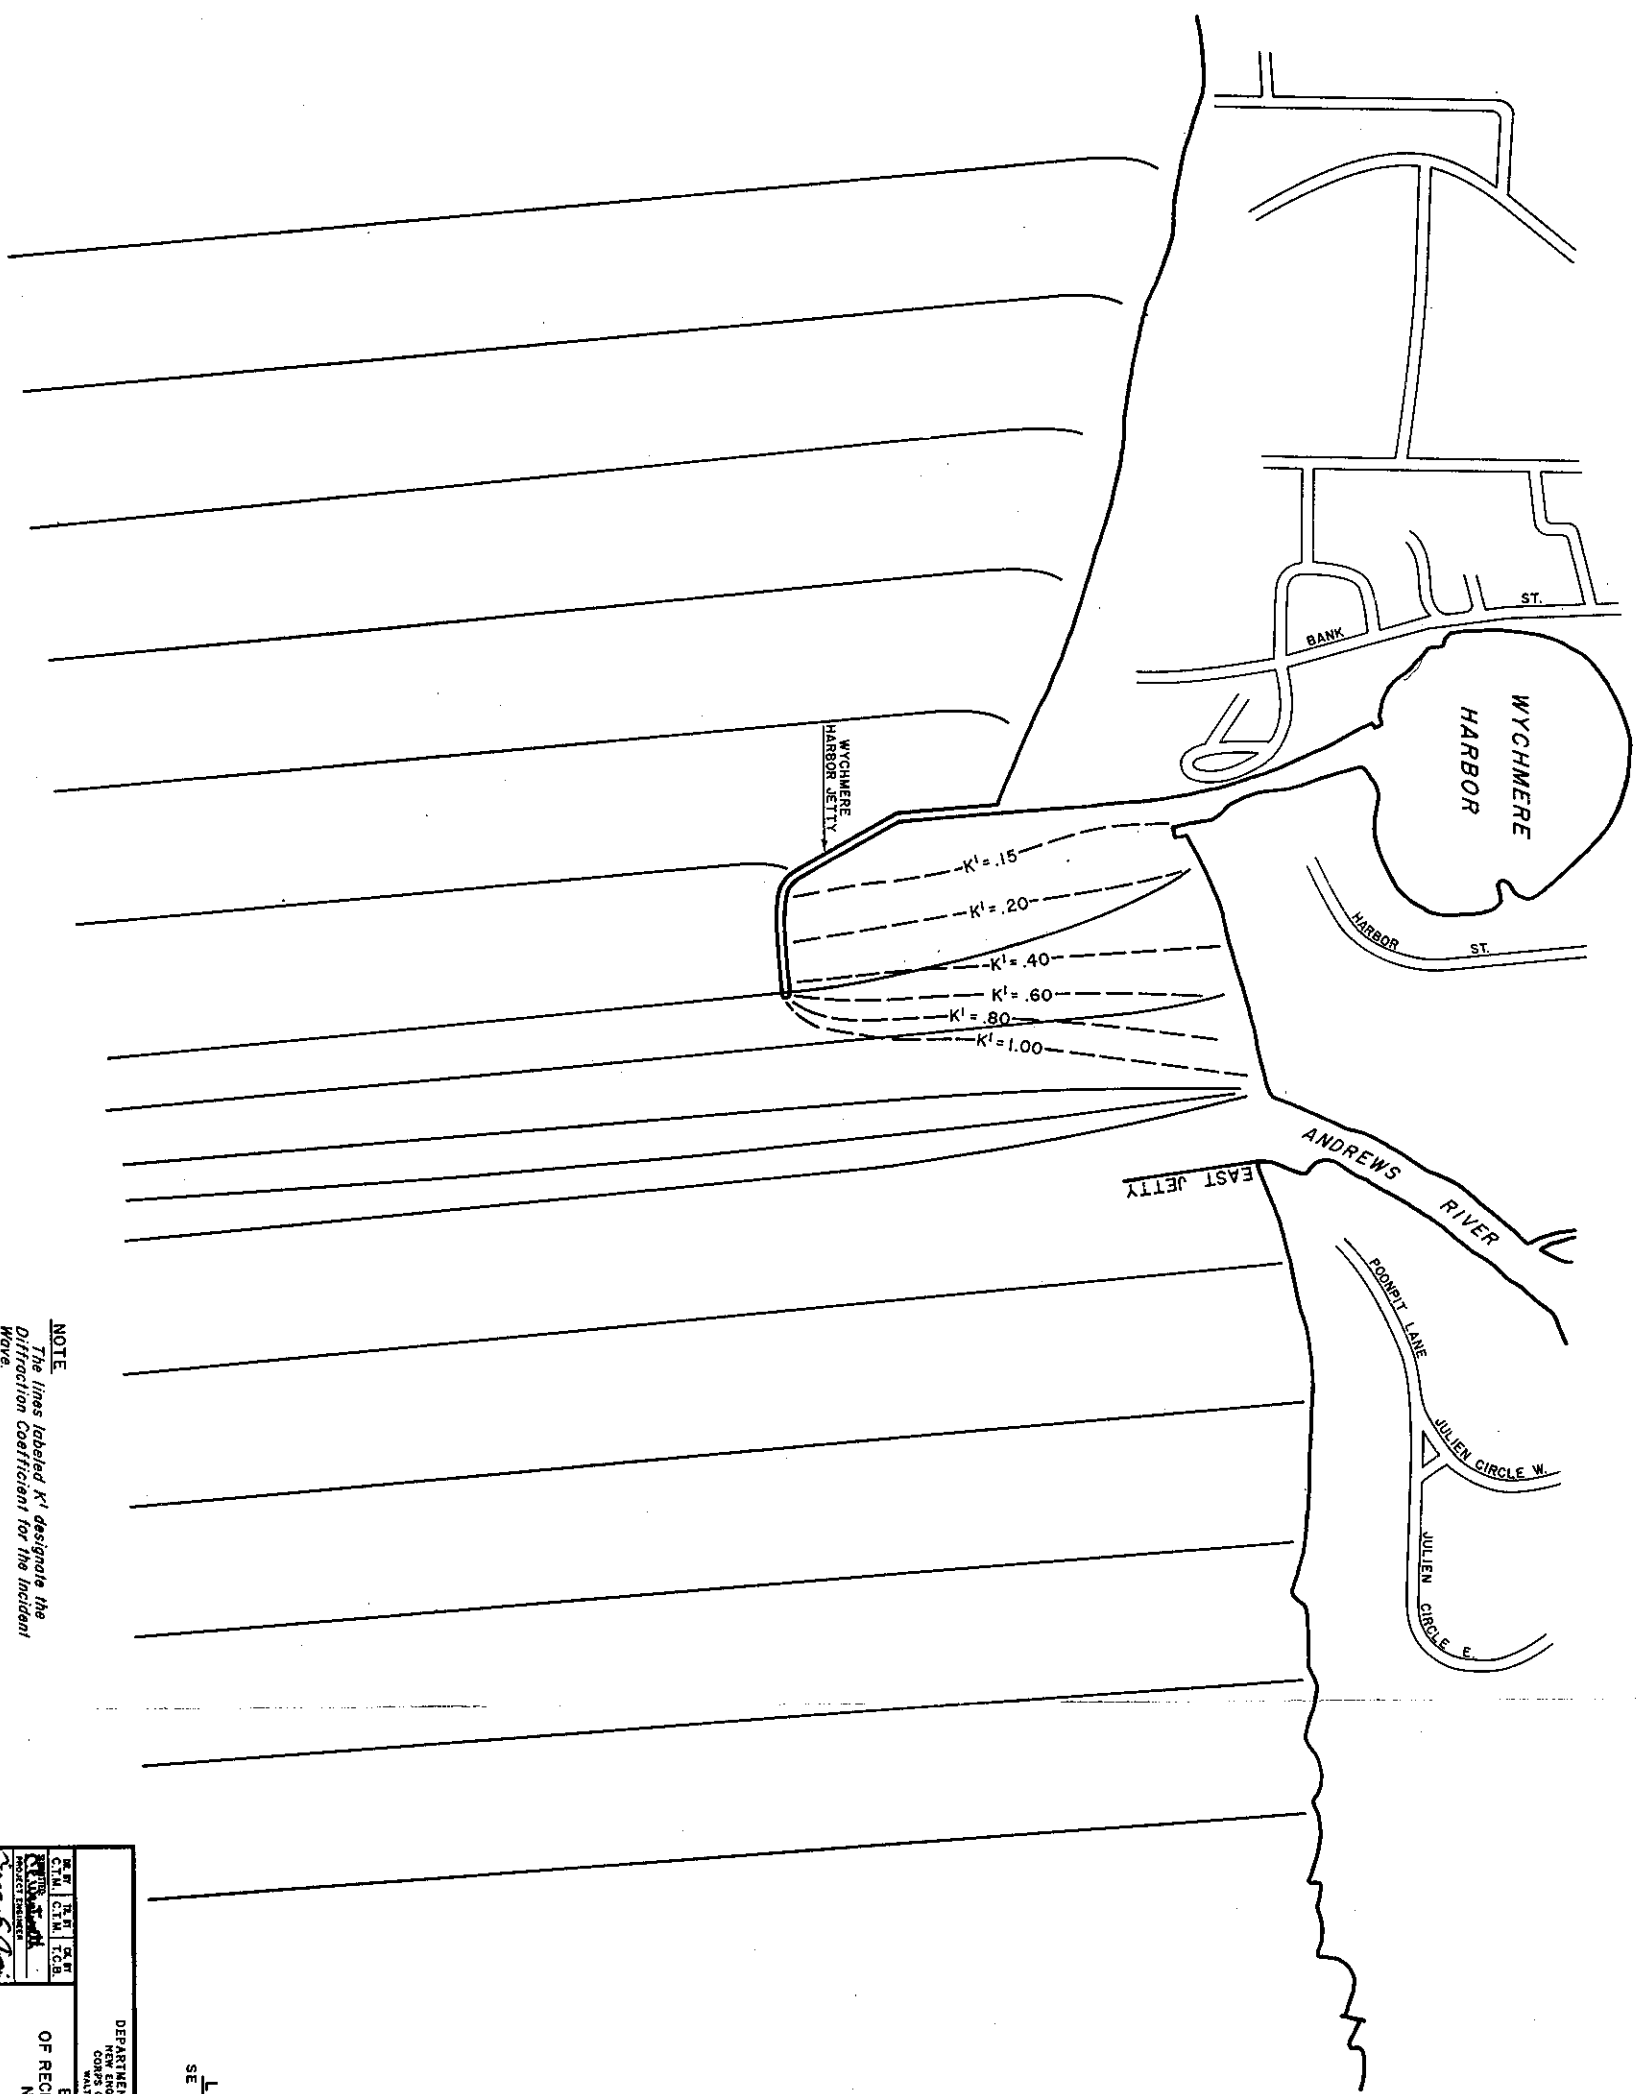
(1) Southeast Approach. The wave analysis for the southeast wave approach is as demonstrated by the orthogonal plot on PLATE 6 and includes the effects of wave diffraction at the Wychmere Harbor jetty structure. The littoral movement of material is to the west, west of the Wychmere Harbor jetty with an eastward trend within the Andrews River - Wychmere Harbor complex. To the east of the entrance, it is generally offshore. Storm wave convergence is experienced along the sector of backshore extending 200 feet west of the Andrews River entrance channel. Wave diffraction and divergence greatly reduces the wave height along the sector of shore immediately east of Wychmere Harbor. Thus, the beach width in this sector remains substantially wider than the remainder of the beach to the east where increased wave energy causes a more rapid alongshore and offshore loss of material.

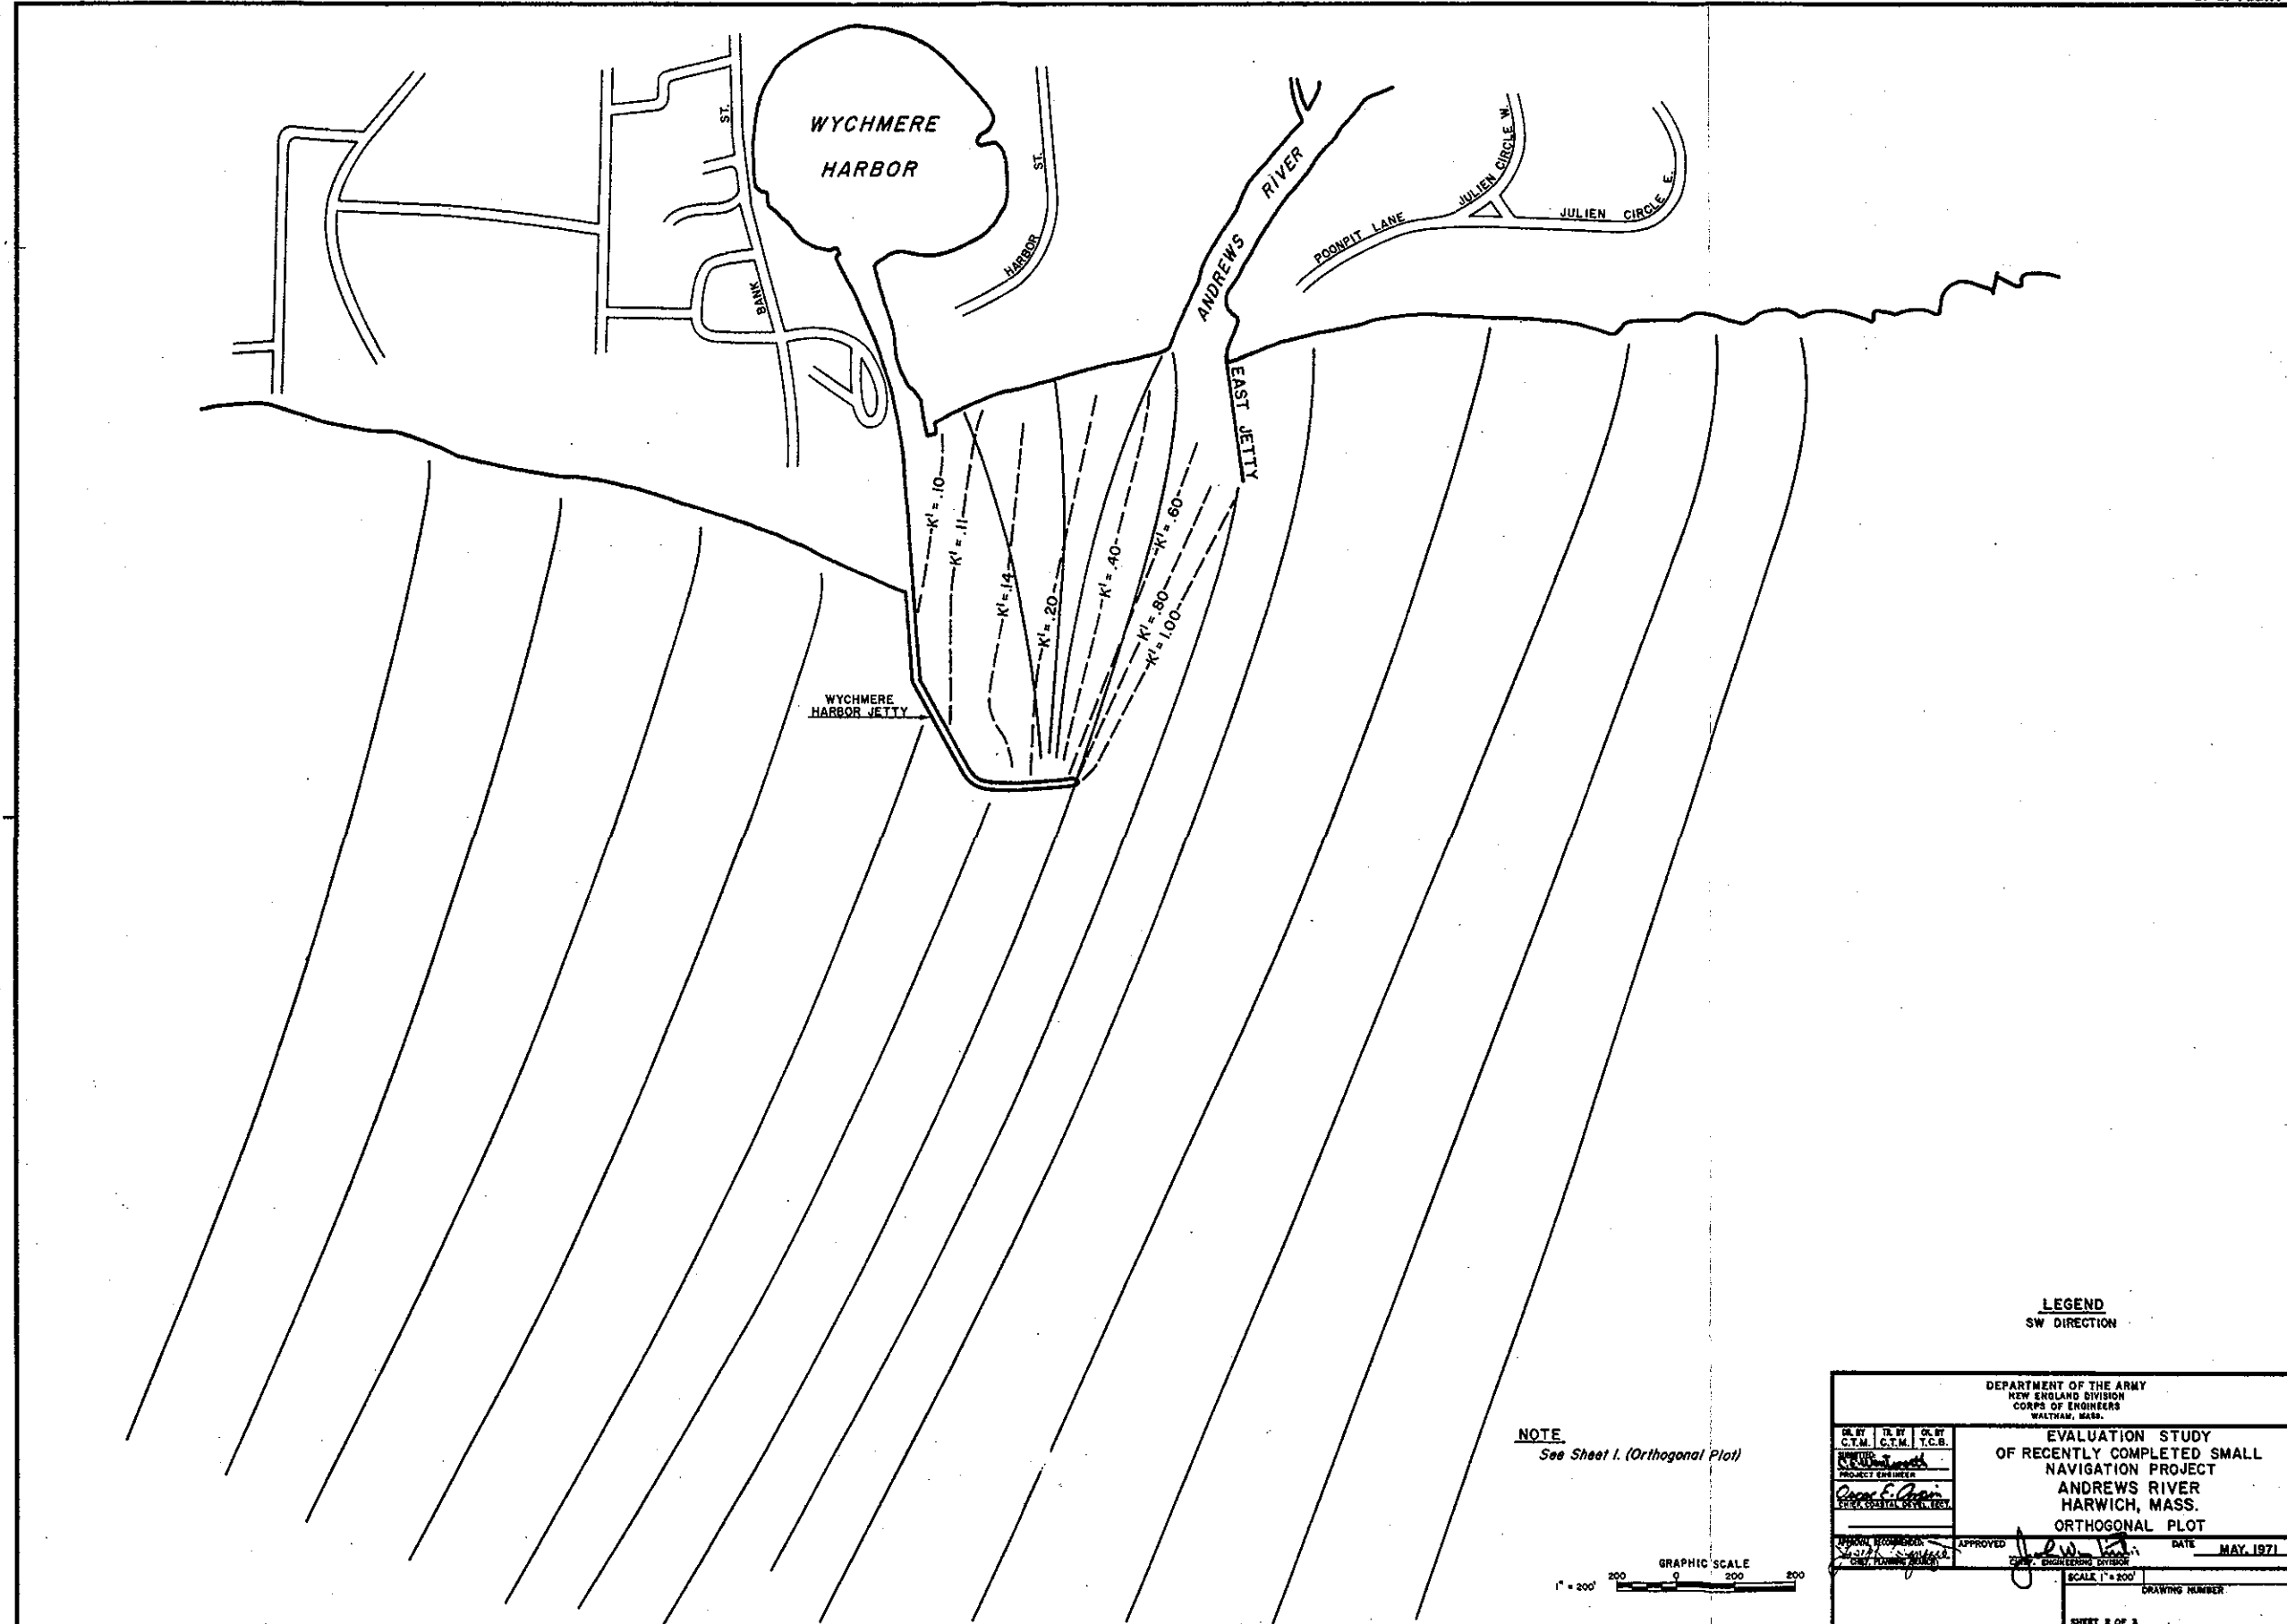
(2) Southwesterly Approach. Very strong eastward littoral movement of material is demonstrated by the orthogonal plots as shown on PLATE 7. The Wychmere Harbor jetty structure affords substantial reduction of wave heights along much of the western portion of shore-front within the Wychmere Harbor-Andrews River sector, thus greatly minimizing the movement of material at the vicinity of Wychmere Harbor, but with increasing eastward movement experienced along the eastern sector to the converging area at the 200-foot sector adjacent to the west entrance to Andrews River.

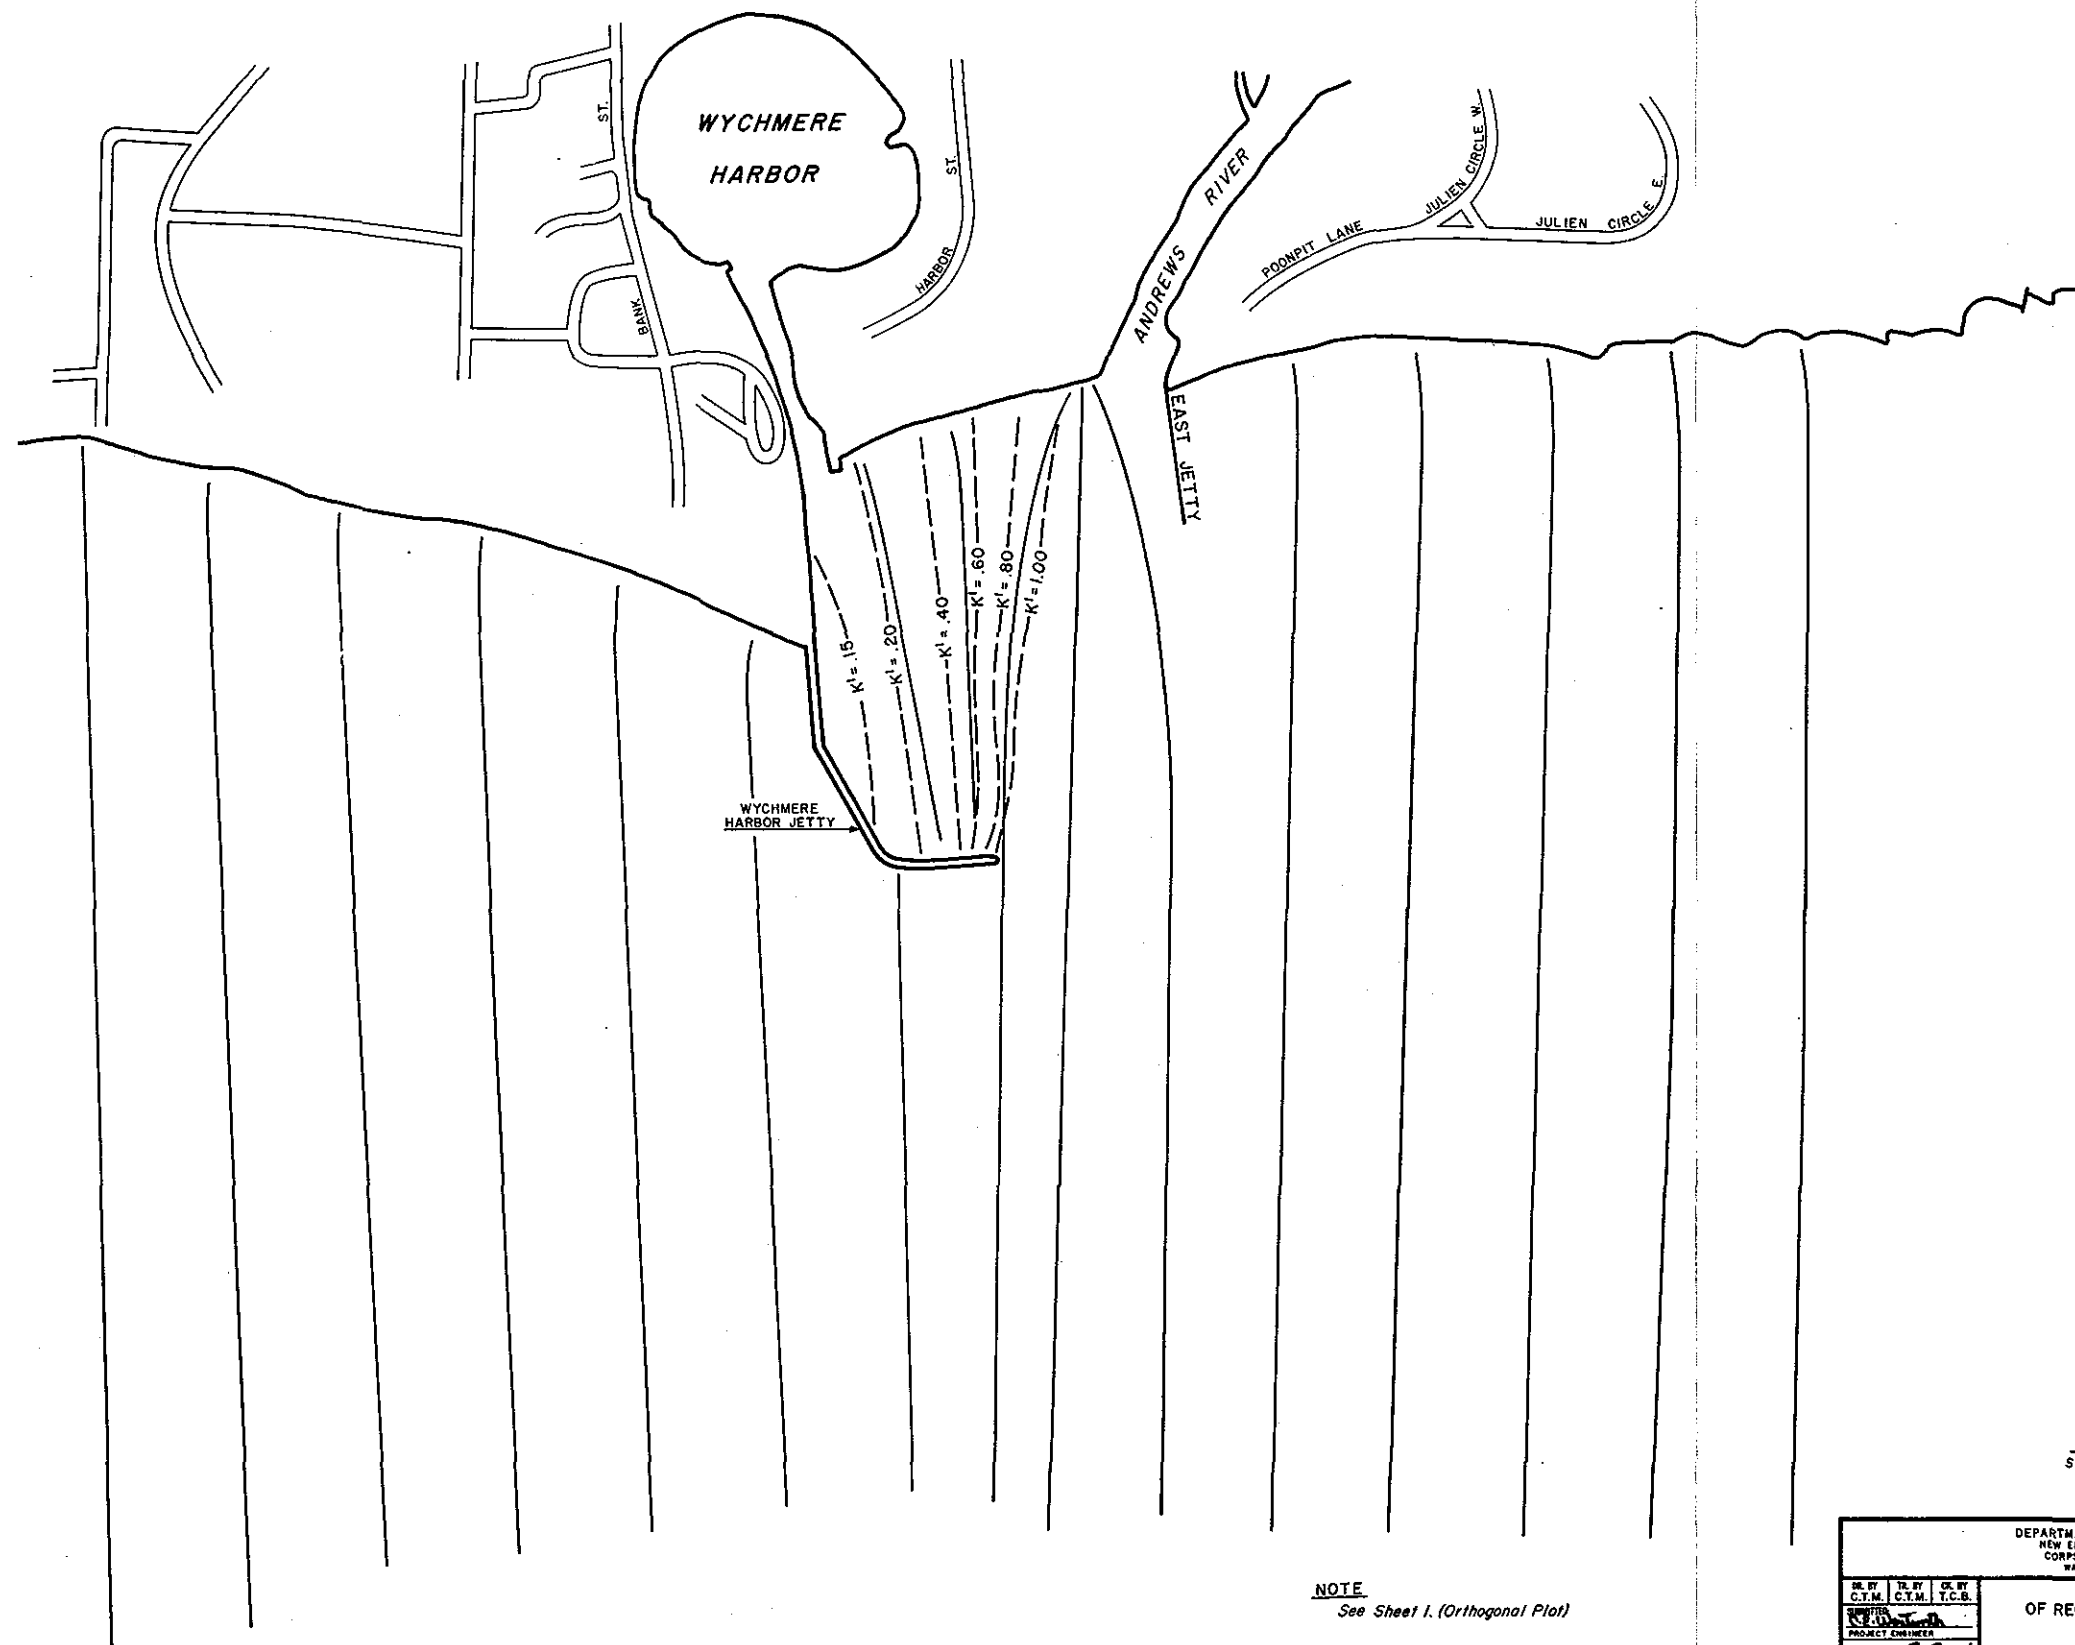
(3) Southerly Approach. The pattern of littoral drift, as demonstrated by the orthogonal plot on PLATE 8, shows a much weaker tendency toward littoral movement, than the southeasterly and southwesterly storm wave approaches. Although there is a slight tendency of westerly movement, west of the Wychmere Harbor jetty and eastward, east of the Andrews River jetty, the predominant movement appears to be offshore. The movement within the Wychmere Harbor-Andrews River complex is reduced through diffraction along the western sector. Similar to the southwesterly and southeasterly approach, substantial convergence of wave energy occurs at the bar that extends normal to the backshore and generally paralleling the western edge of the Andrews River channel.
